Balboa Islands Seawall Rehabilitation Project

Rehabilitation Options

City Council Study Session
July 14, 2015

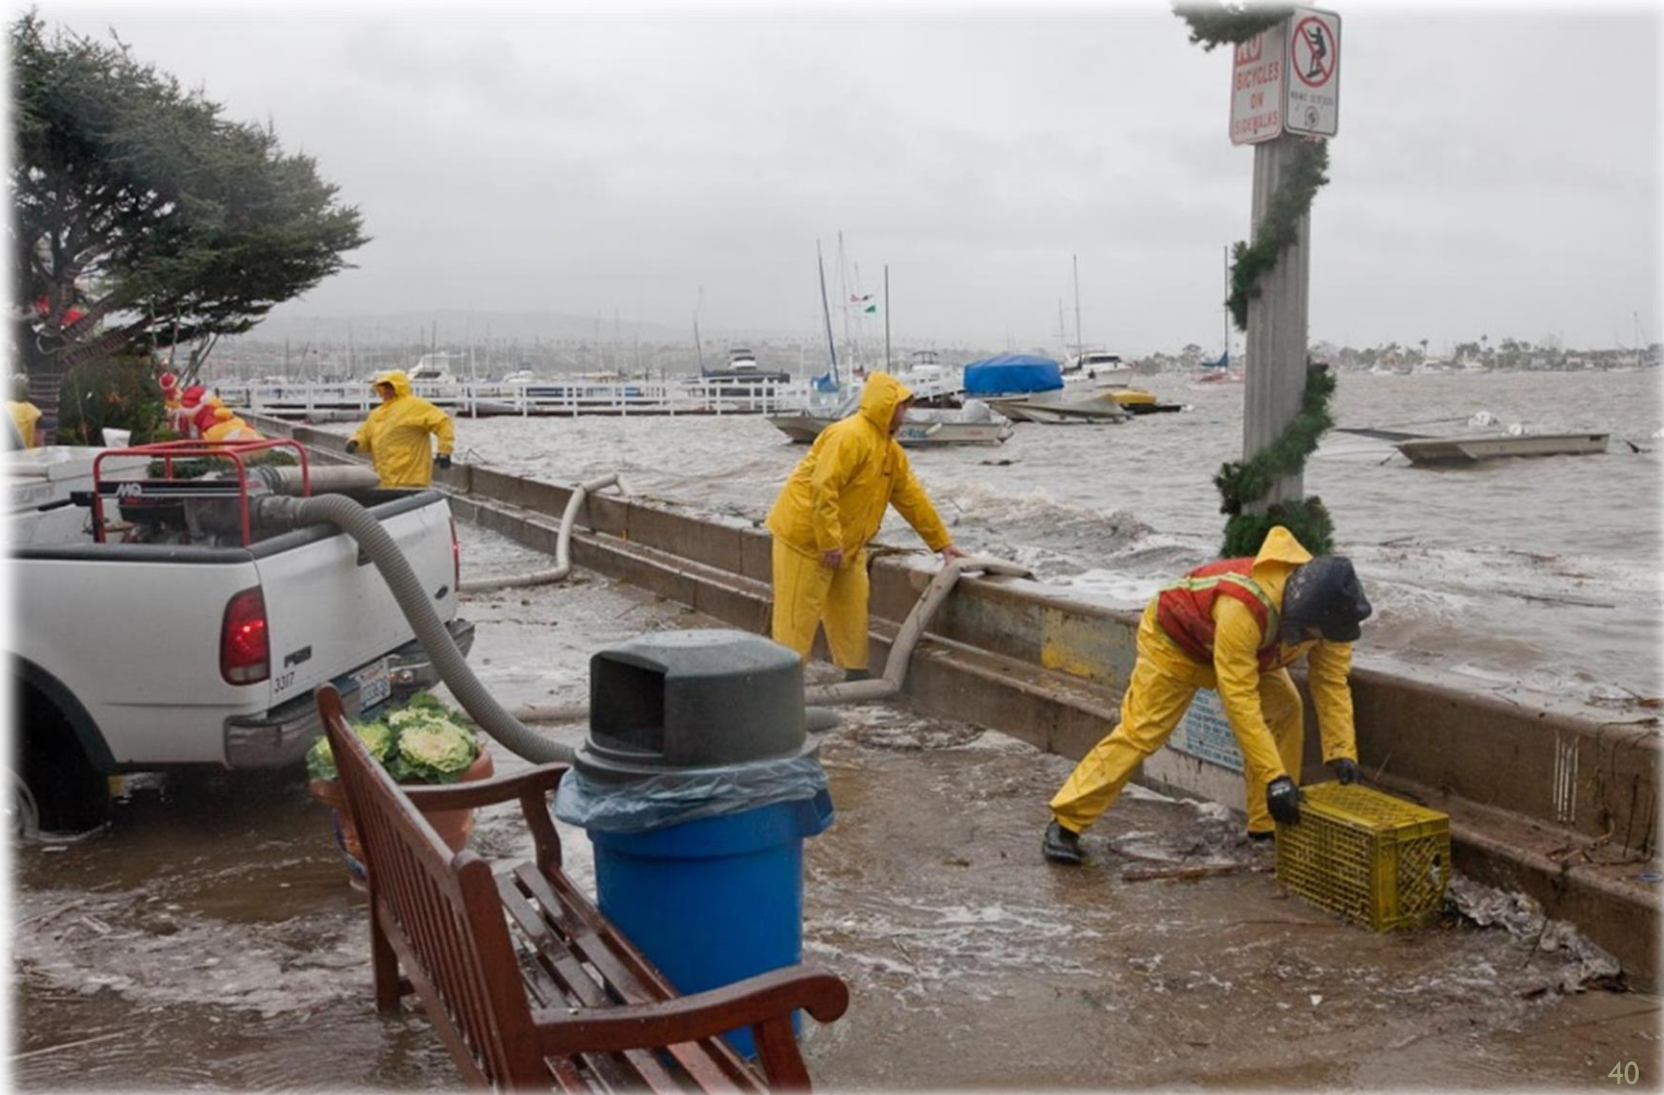
MOD staff mobilize portable emergency pumps to bail accumulating rain and over-topping flows.

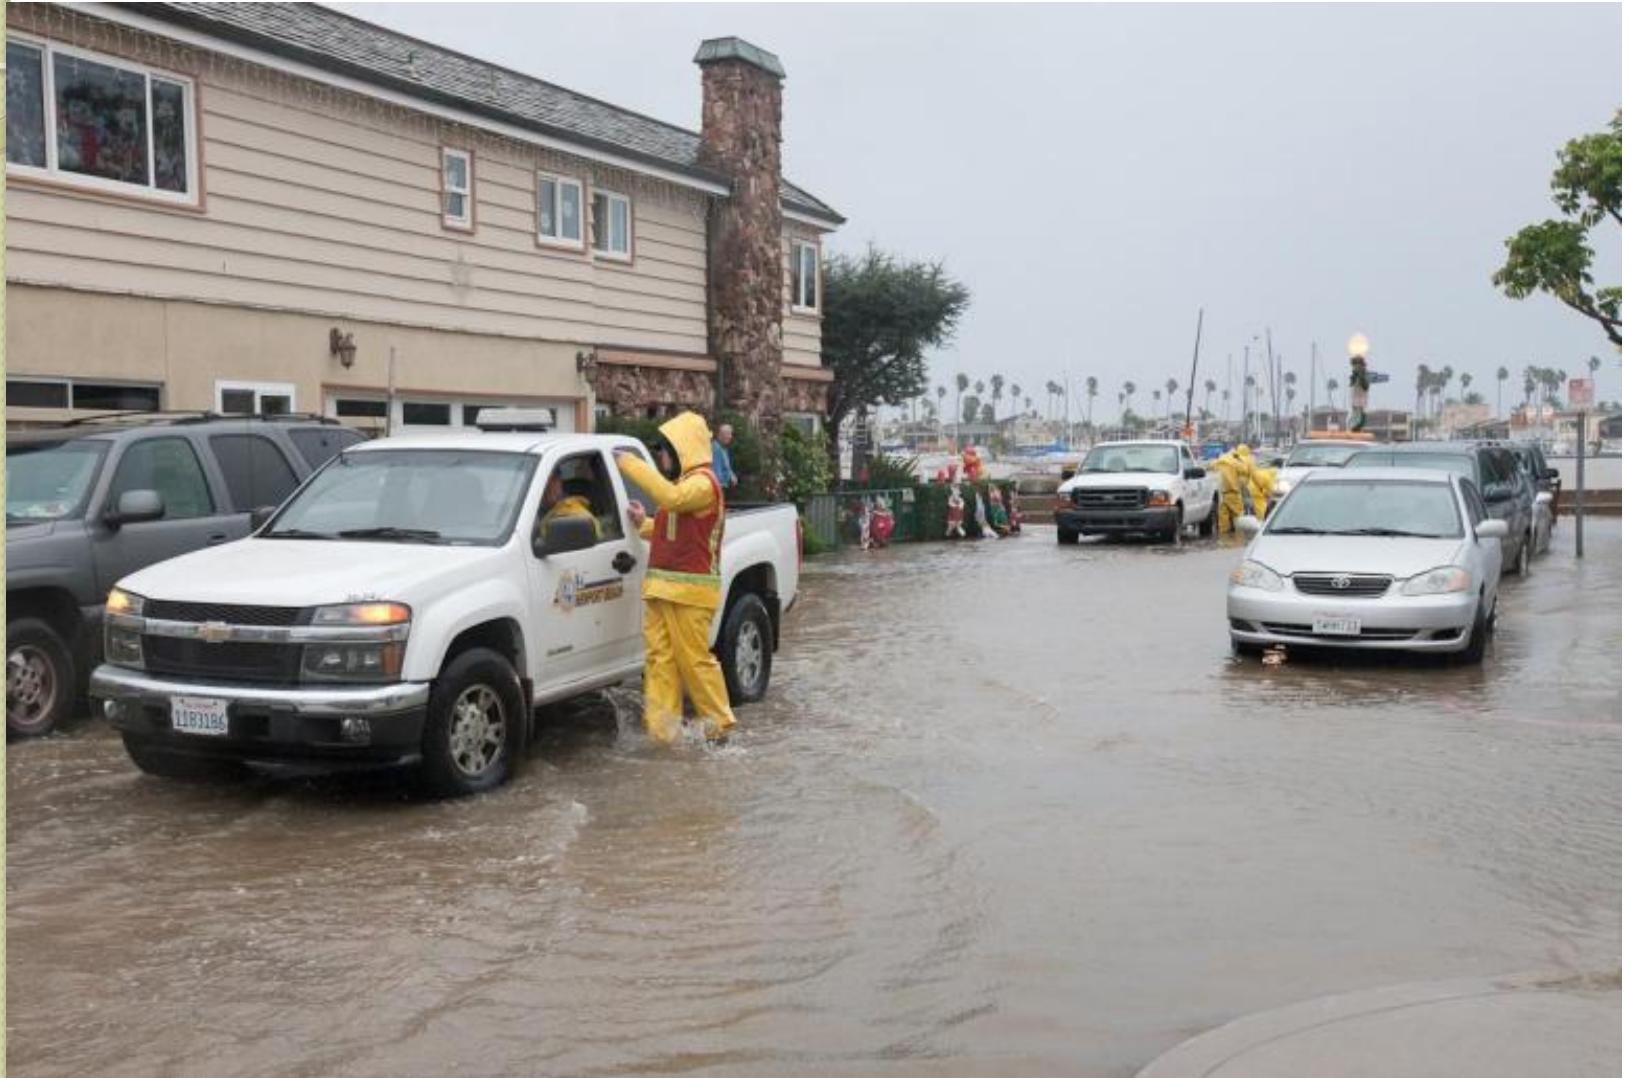
Street Flooding Overtopping Curb at Turquoise Avenue (December 22, 2010)

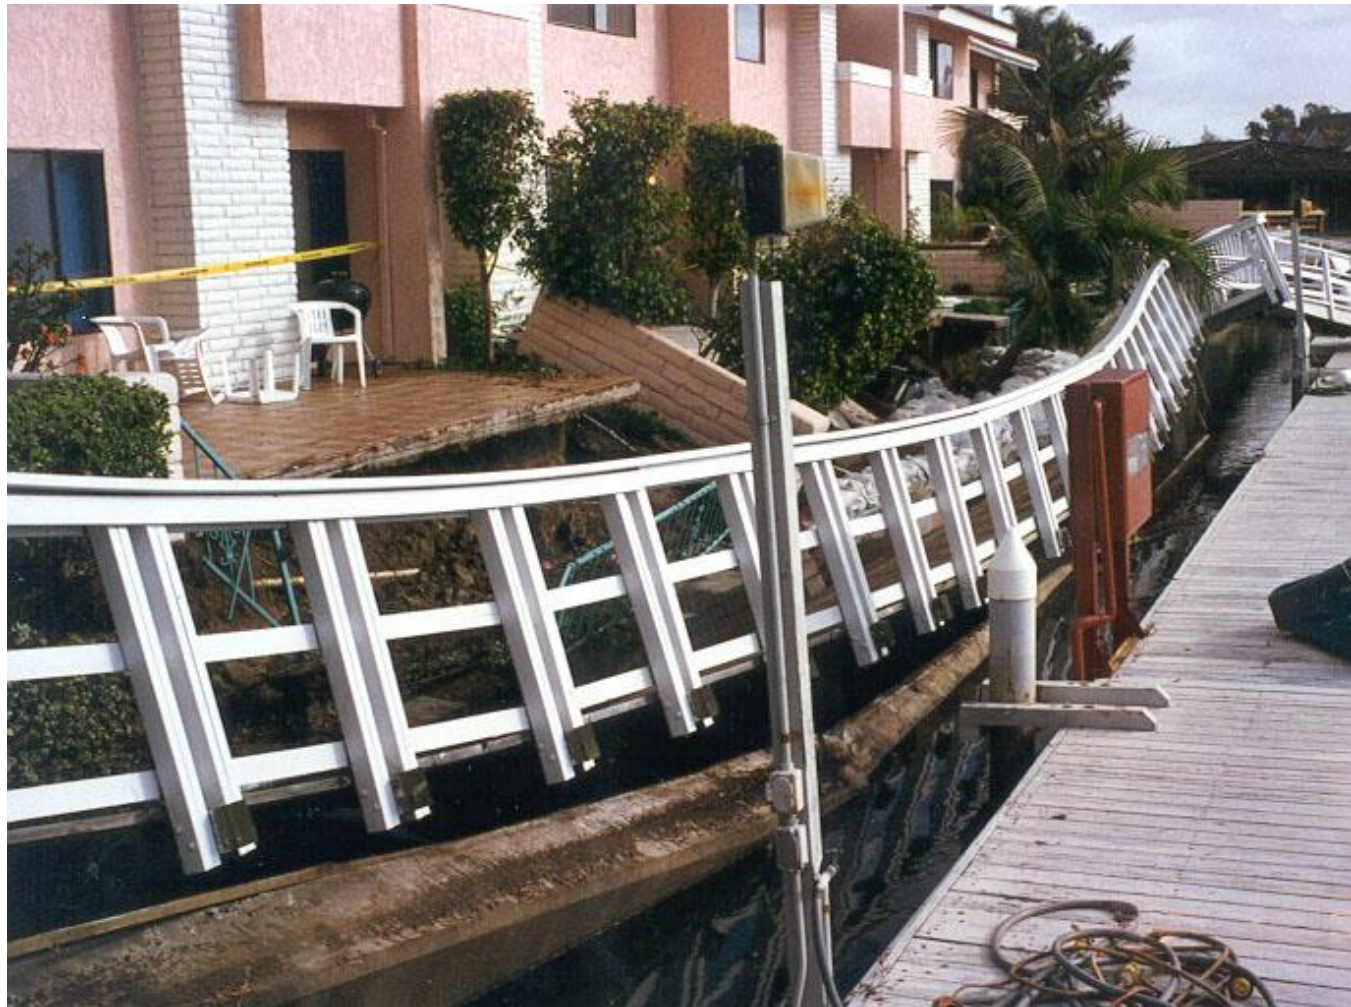
Seawall Failure – Shallow Pile Embedment

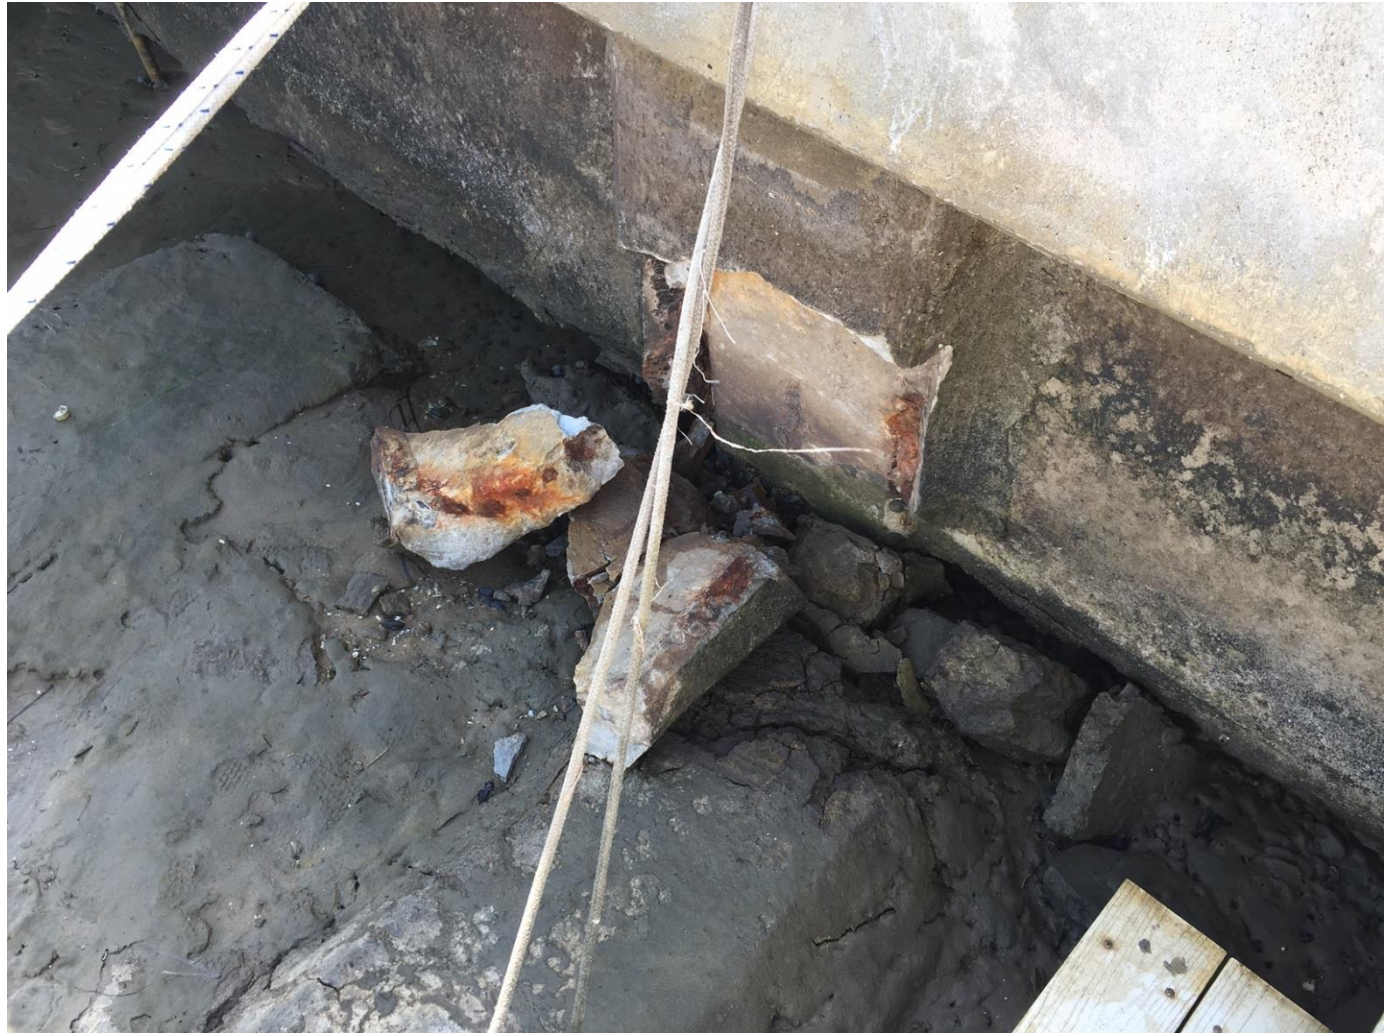
Grand Canal: Cap Veneer Spalled

- a. Wall veneer is failing.
- b. Very shallow embedment of soldier piles and concrete planks (~2 to 3 feet).
- c. Corroded tie rods.
